ST. MONICA'S CHURCH

Rochester, N.Y.

Survey--March 10, 1932.

by W. J. White, Engineer.

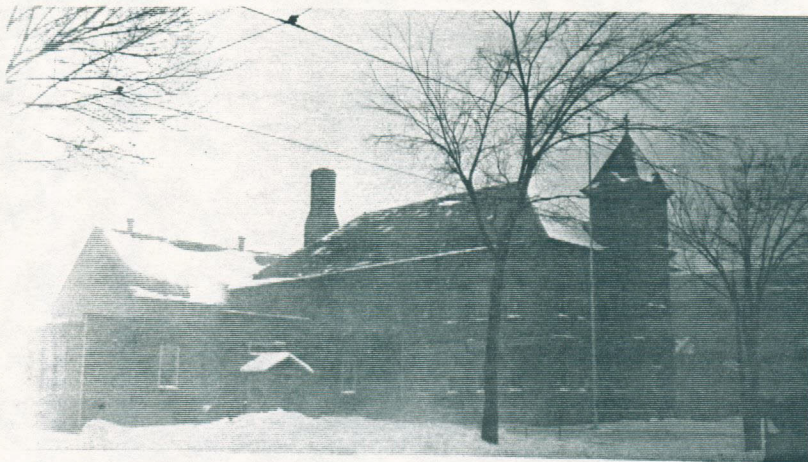
School, 837 Genesee St.

Construction: Two stories, attic and cellar. Walls 12" brick. Roof tin and wood shingle covered 1" joisted. Floors 1" joisted. Walls close plastered. Wood sheathing and composition board finish. Open stairs. Two low pressure boilers, brick stack, safe. Built 1898. Fair condition.

Occupancy: School with hall in basement.

Protection: One soda acid extinguisher each floor.

1. All unnecessary combustible material should be removed from basement.
2. An approved supply of chemical extinguishers calls for three on each floor and in the cellar.
