ST. MONICA'S CHURCH

ROCHESTER, N.Y.

Survey--March 10, 1932.

by W. J. White, Engineer.

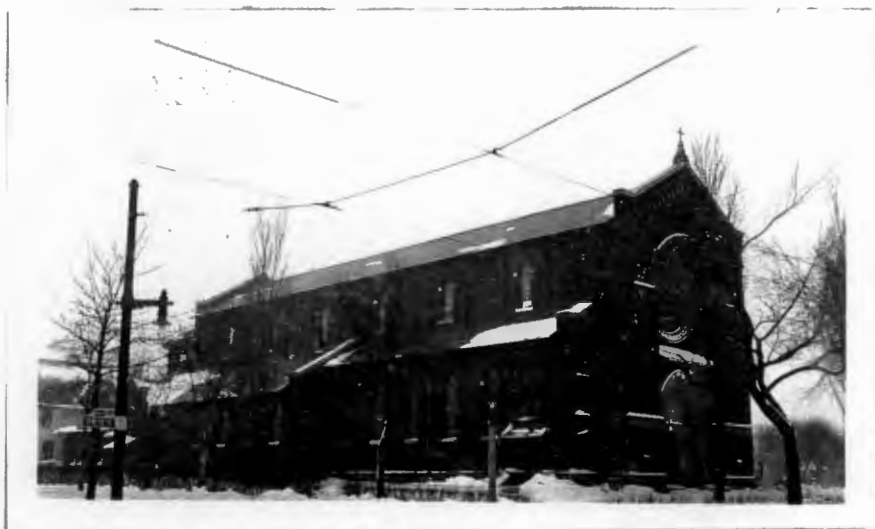
Church 833 Genesee St.

Construction: One and one equals three stories with small basement for boiler and choir locker room. Walls 12 to 16" brick. Roof slate covered 1" on joist, wood purlins and trusses, supported by the walls and interior marble covered columns. Floor is tile covered 1" on joist, wood beams and brick piers. Floor over choir locker room is joist. Floor over the boiler room is reinforced concrete. Moderate decorations. No blind attic. Steam heat. Boiler safe in fire resistive basement. Good condition thruout.

Protection: Three soda acid chemical extinguishers.

1. All unnecessary ^{removed} combustible material ^{from} should be removed from basement, particularly from the ventilating tunnel.

2. Additional chemical exinguishers should be provided as follows: Basement, one: Main floor, four: Balcony, one.

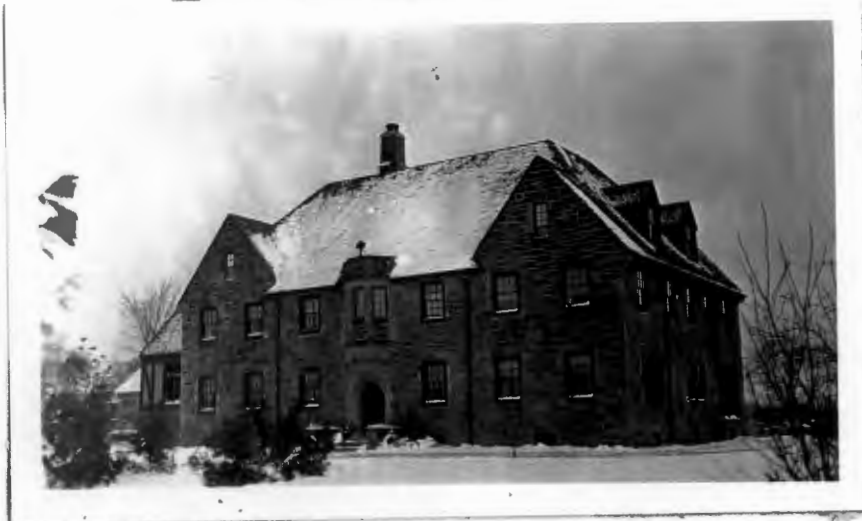
Convent 38 Milbank St.

Construction: A two story, attic and cellar building. Walls cinder block faced with stone. Roof slate covered 1" joisted. Floors double 1" joisted. Interior finish, metal lath and plaster. Stairs in a cinder block tower with labeled kalamein doors. Good woodwork. Excellent condition. New.

Protection: None

1. I would suggest that at least two soda acid chemical extinguishers be provided.

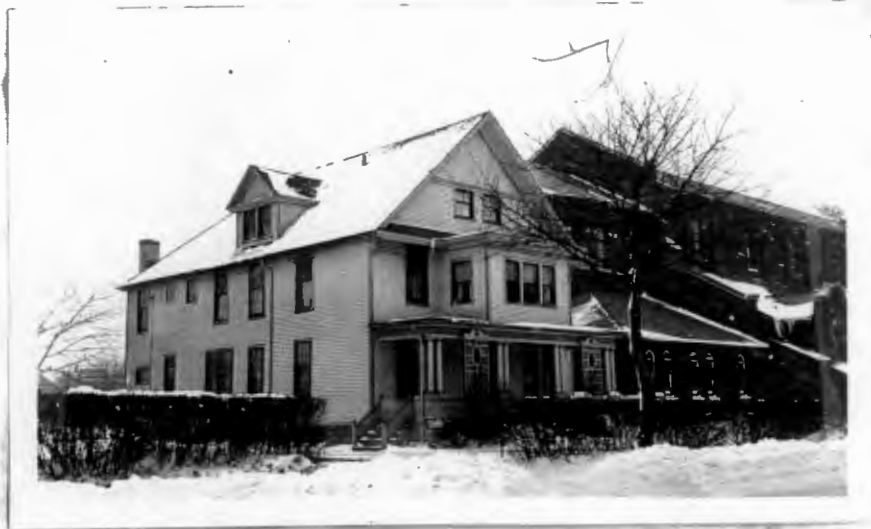
Rectory, 34 Monica St.

Construction: A two story, attic and cellar, frame joisted, shingle roofed dwelling in good condition. Low pressure steam heat.

Protection: None

1. I would suggest that a chemical extinguisher be placed in the cellar.

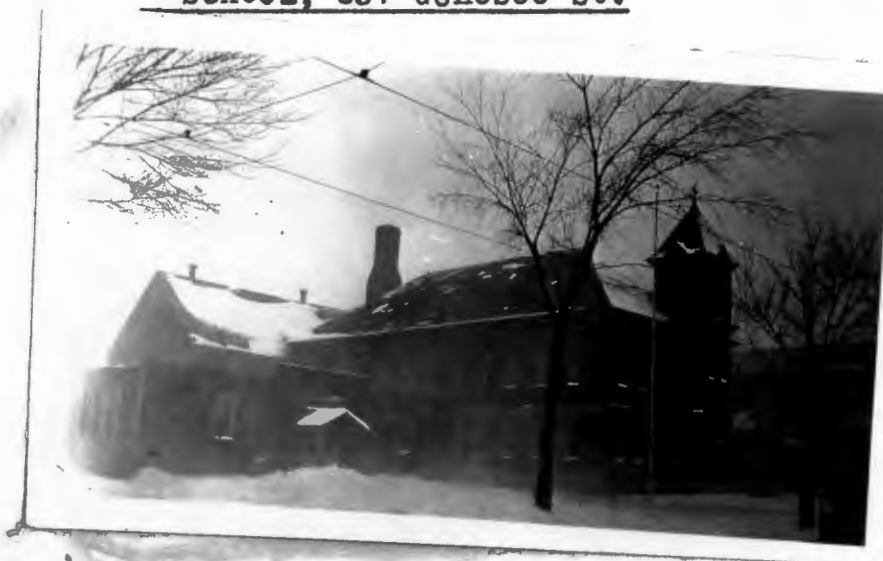
School, 837 Genesee St.

Construction: Two stories, attic and cellar. Walls 12" brick. Roof tin and wood shingle covered 1" joisted. Floors 1" joisted. Walls close plastered. Wood sheathing and composition board finish. Open stairs. Two low pressure boilers, brick stack, safe. Built 1898. Fair condition.

Protection: One soda acid extinguisher each floor.

1. All unnecessary combustible material should be removed from basement.
2. An approved supply of chemical extinguishers calls for three on each floor and in the cellar.
